TRIP REPORT

DATE: May 1, 2014

LOCATION: TERRY JONES PROPERTY, EMMETT IDAHO

TERRY JONES
CONSTRUCTION AND SITE PHOTOS

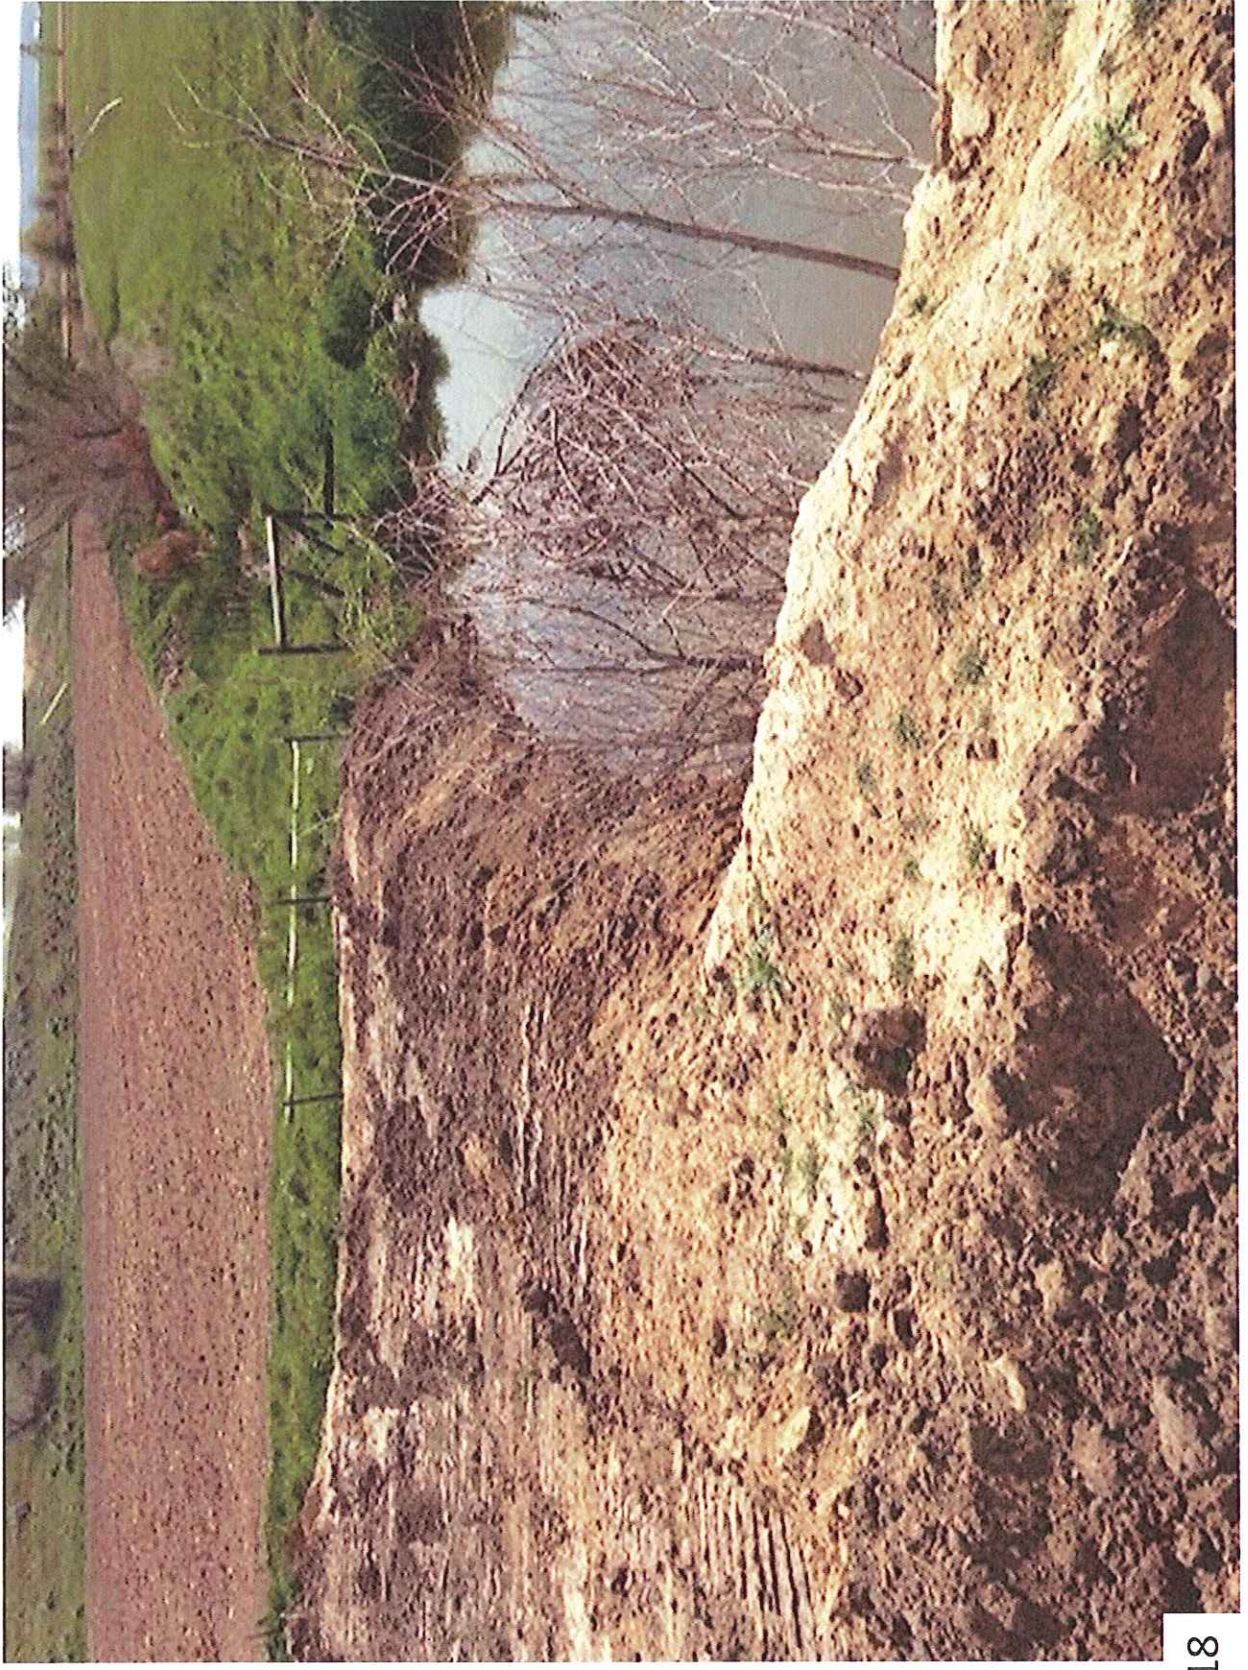
The berm between the irrigation tail water pond and the irrigation water (see pages 11 and 12 of the photos) is approximately 25 feet wide. Mr. Jones also stated that an impermeable liner was placed vertically in the berm to prevent water from the tail water pond leaching into the irrigation water. The top of the newly constructed berm is about 420 feet long and 14 to 18 feet wide. Measurements were taken using a measuring wheel. The north side of the berm slope is approximately a 3 to 1 slope with the south slope varying from a 1:1 to 2:1.

Another view, looking south. Canal water flows south through Kipper's property.

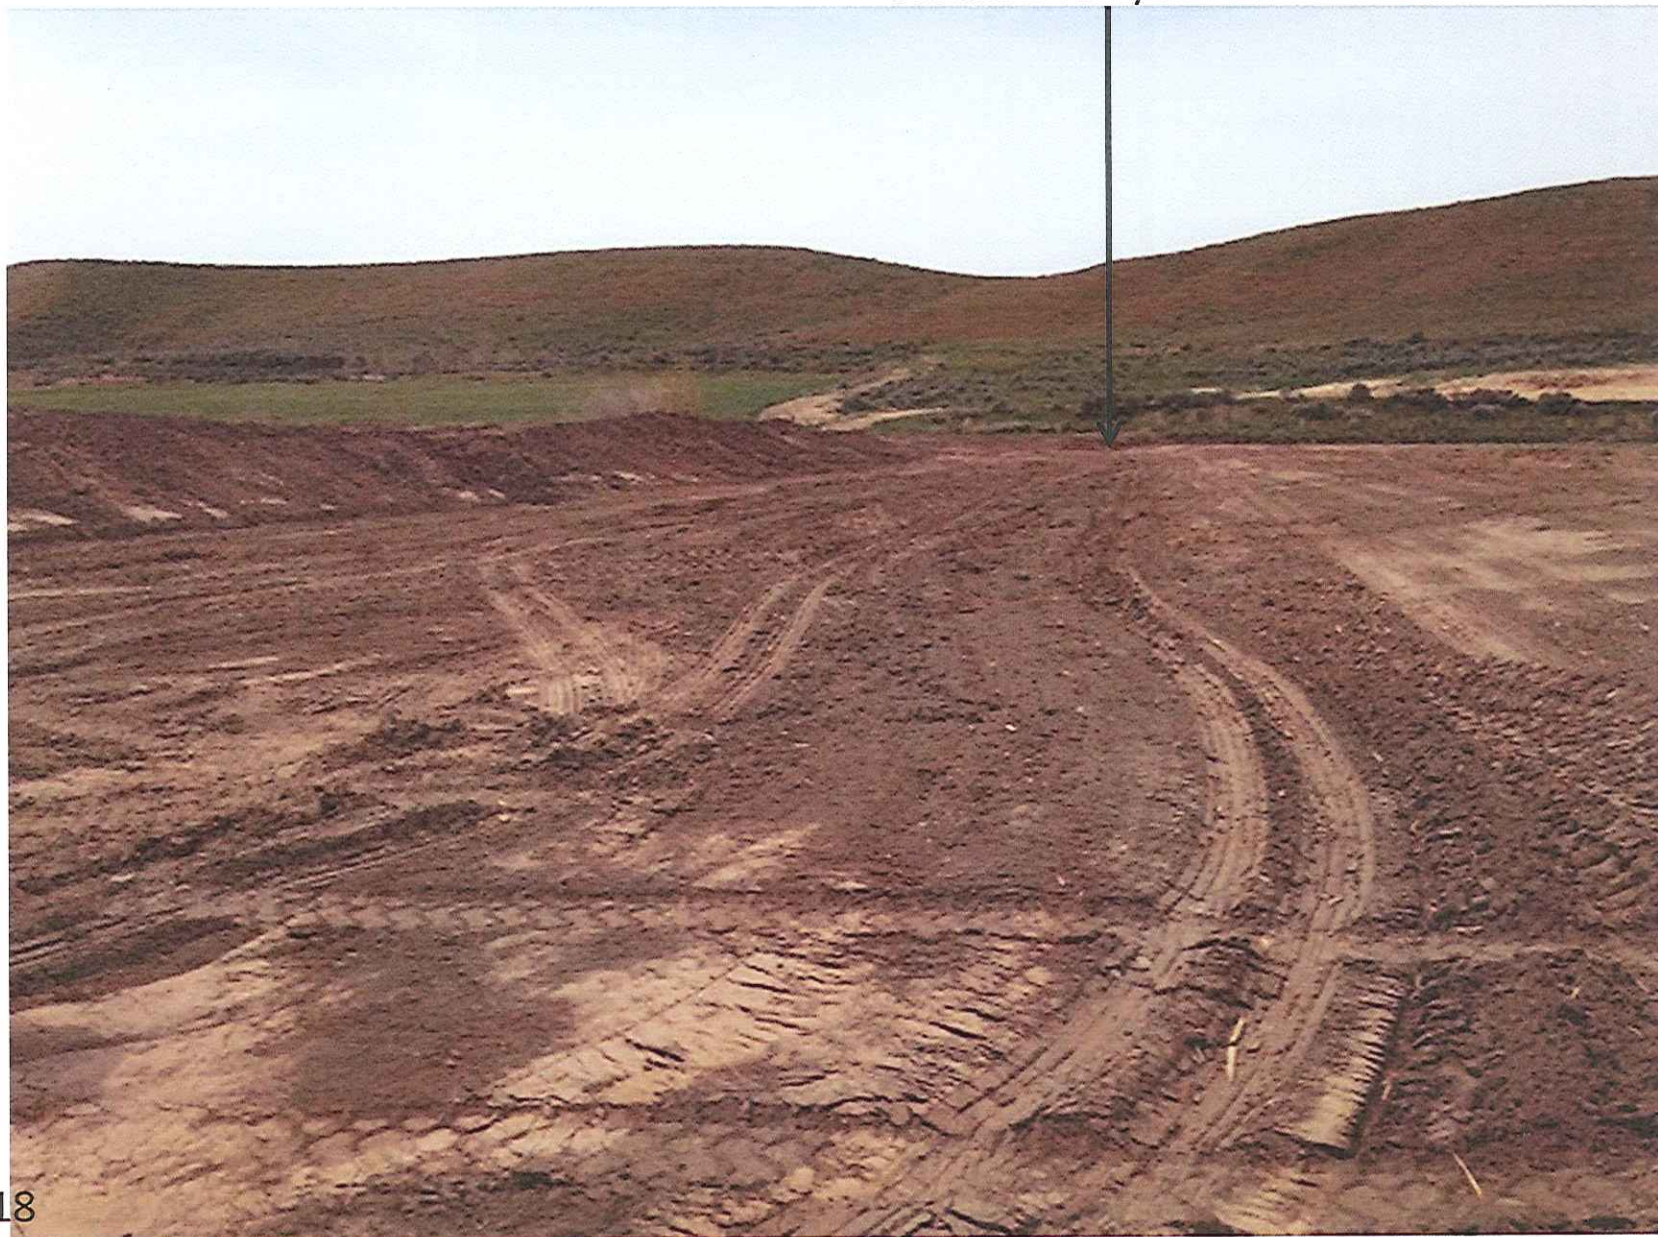
Another view, looking approximately west-southwest of the newly constructed berming.

Channel (see next photo) created to divert runoff into this bermed containment/collection area

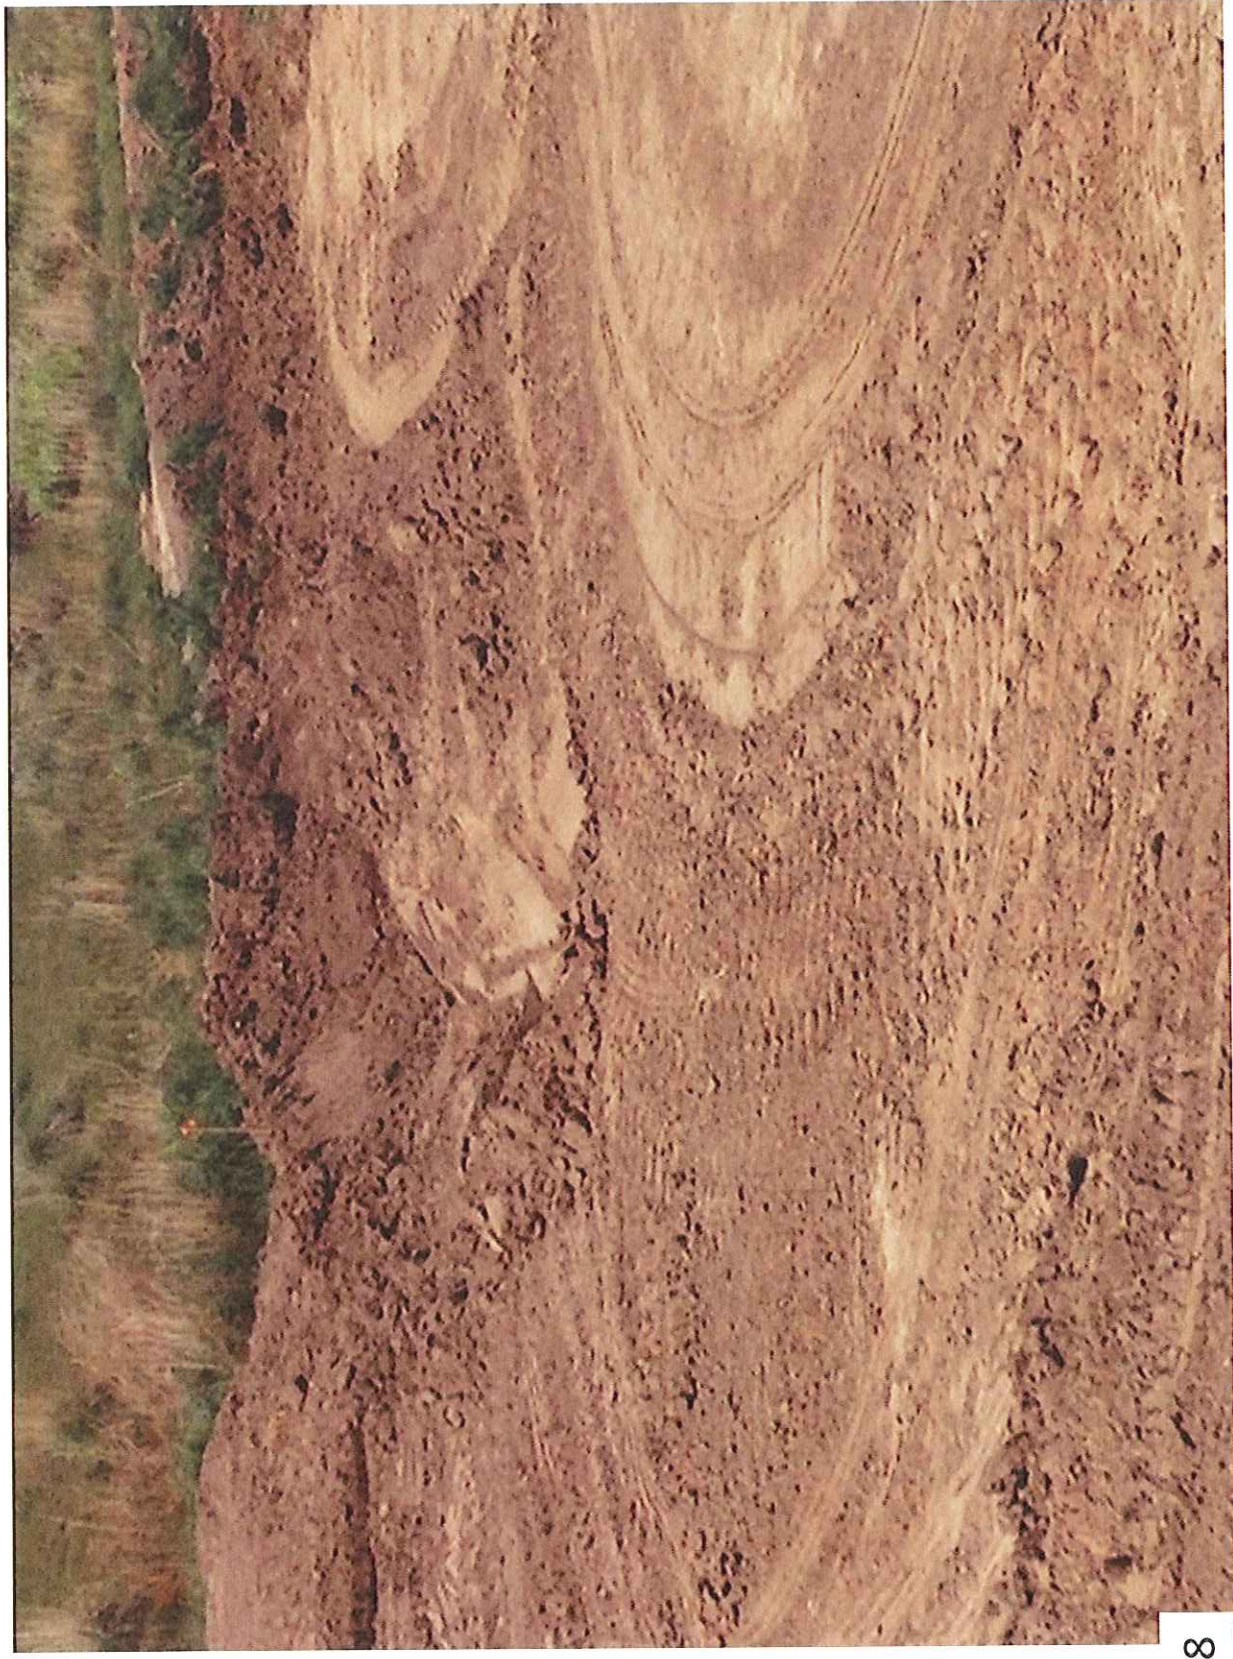
Close-up of the end of the diversion ditch.

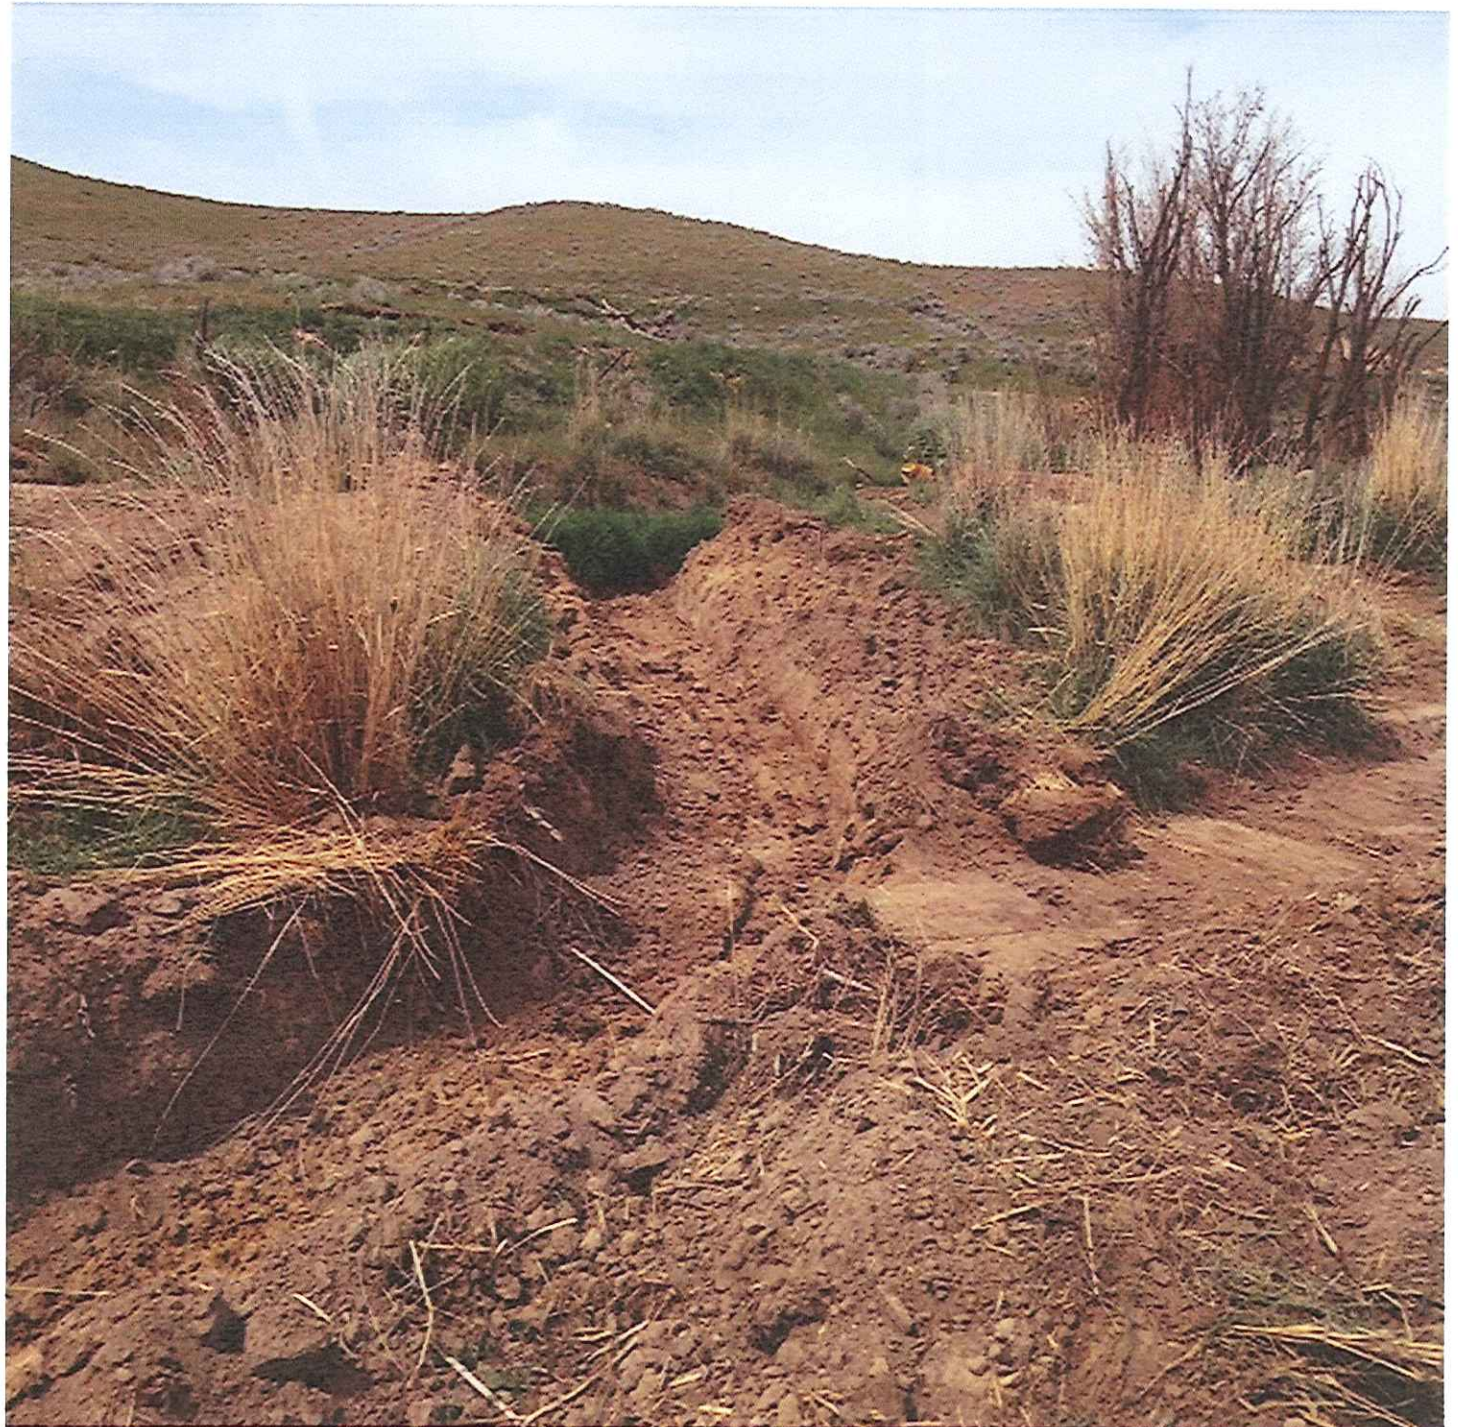
Close-up of the beginning of the diversion ditch.

The facility will be able to collect all the runoff water from land application.

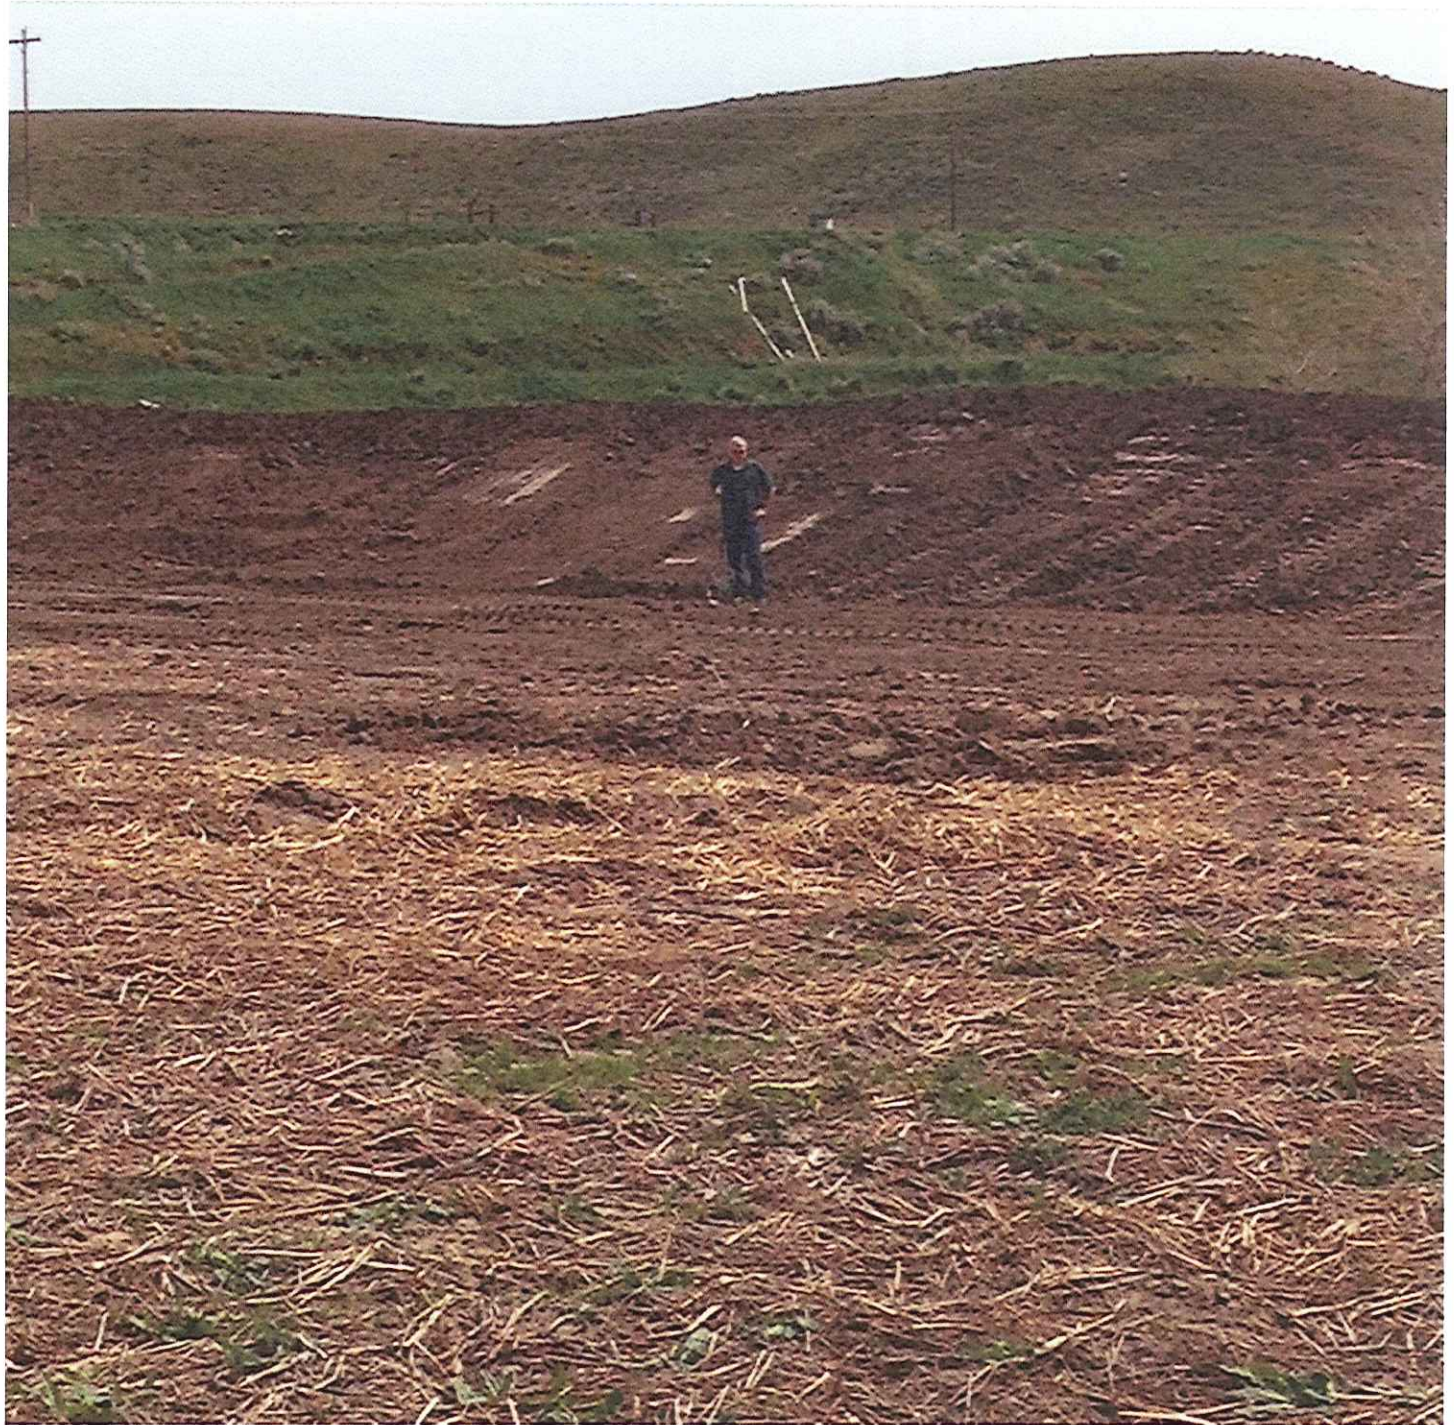
Photo of the berm.

John Bilderback,
pictured. Height 6'1"

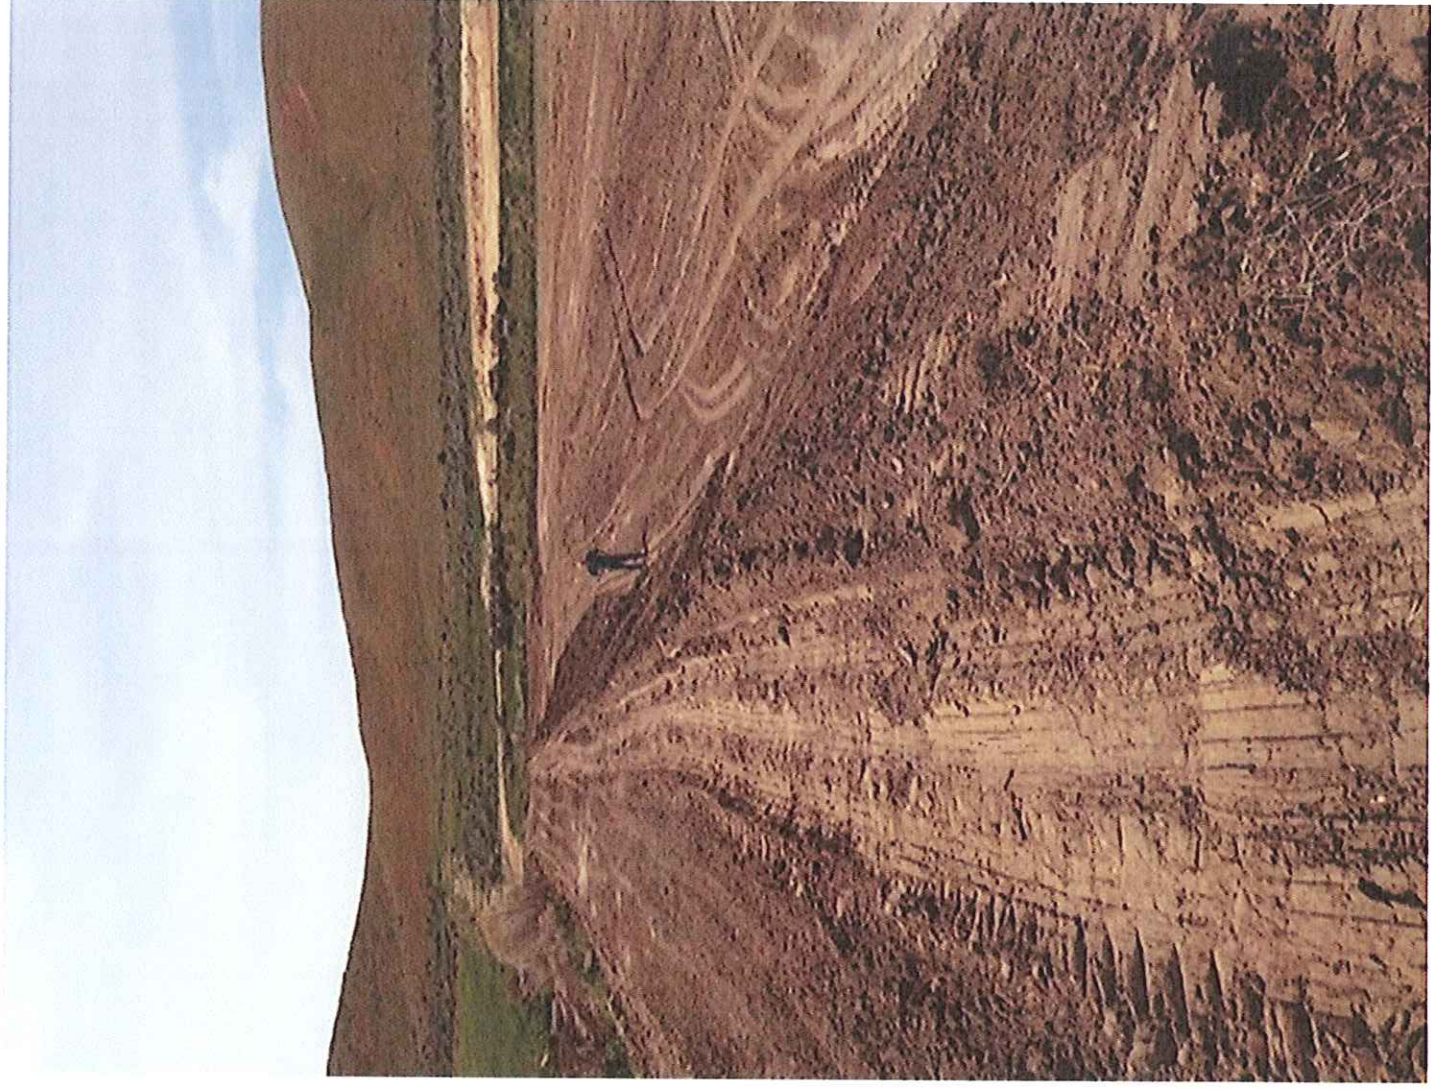
Looking west. Photo
of the berm.

John Bilderback,
pictured. Height 6'1"

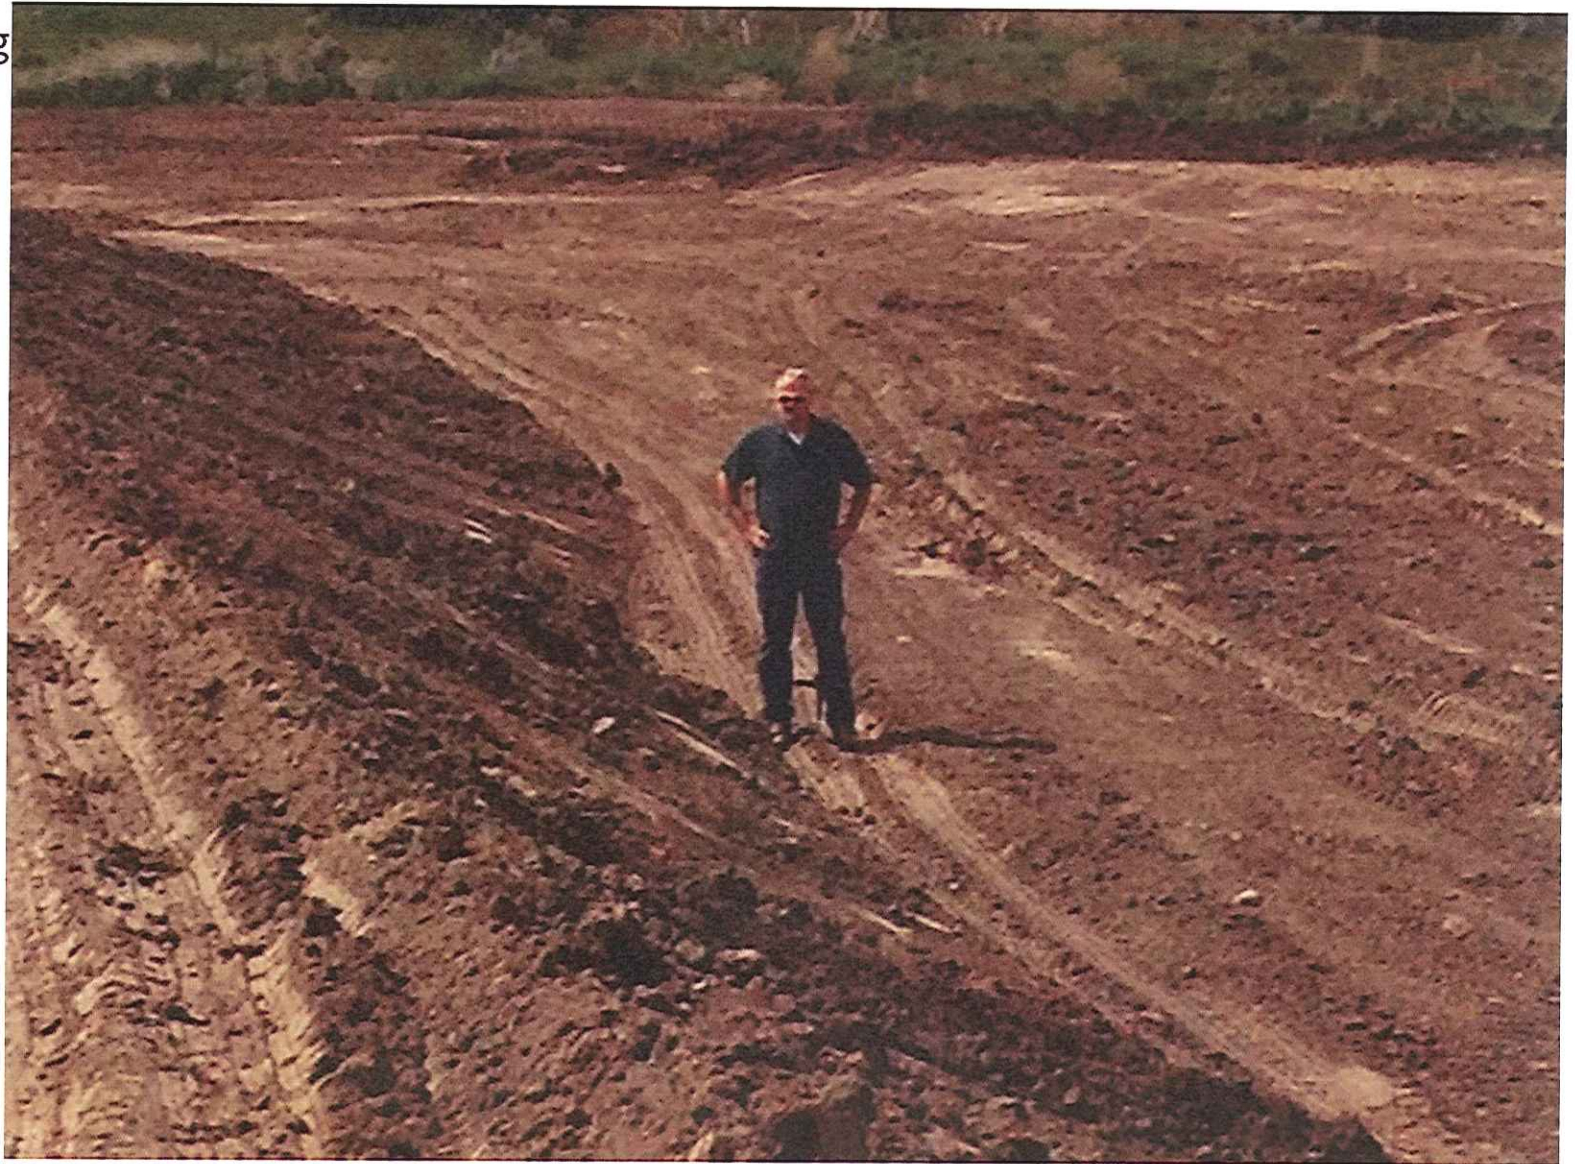
Mr. Bilderback used an approximately 3' soil penetrometer to test the berm and the floor of the containment area. It was found the compaction to be inadequate to meet the requirements of the Dairy Waste Rules. To have this area approved for dairy waste containment, the compaction and soil would have to meet the requirements. Mr. Bilderback did not take soil samples since the compaction of the facility was not met and at this time, Mr. Jones stated he has no intention of containing dairy waste in this area.

Note: 3 foot long
Soil
Penetrometer is
pushed all the
way into the
ground, noting
that compaction
is not adequate
to meet dairy
waste rules. If
this area will be
utilized in the
future for dairy
waste manure or
water storage,
the area would
need to be
compacted and
the soils would
have to be tested
to ensure it
would meet
IDAPA 02.04.14
Rules Governing
Dairy Waste
